## **PAVEMENT CAUSED FOD TO AIRCRAFT ENGINES**

### **Transportation Systems 2004 Workshop**

Naval Facilities Engineering Service Center  
Port Hueneme, California

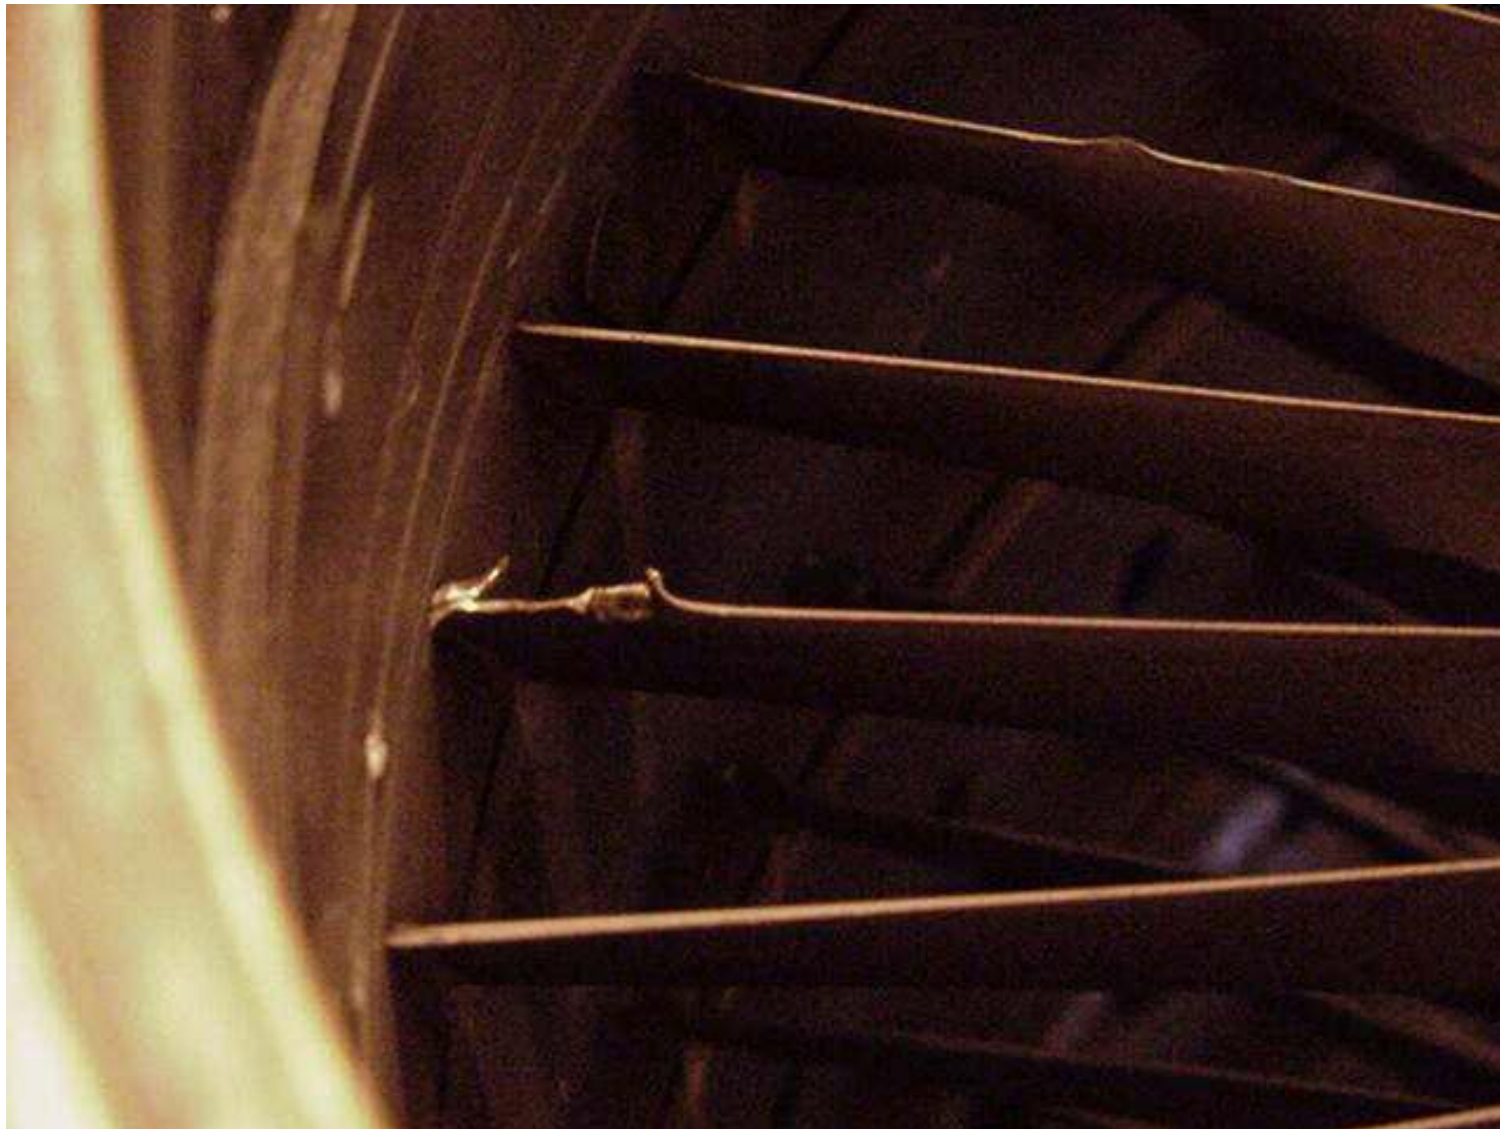
# Damage Caused By Fastener

(Photo Courtesy of Failure Analysis Service Technology)

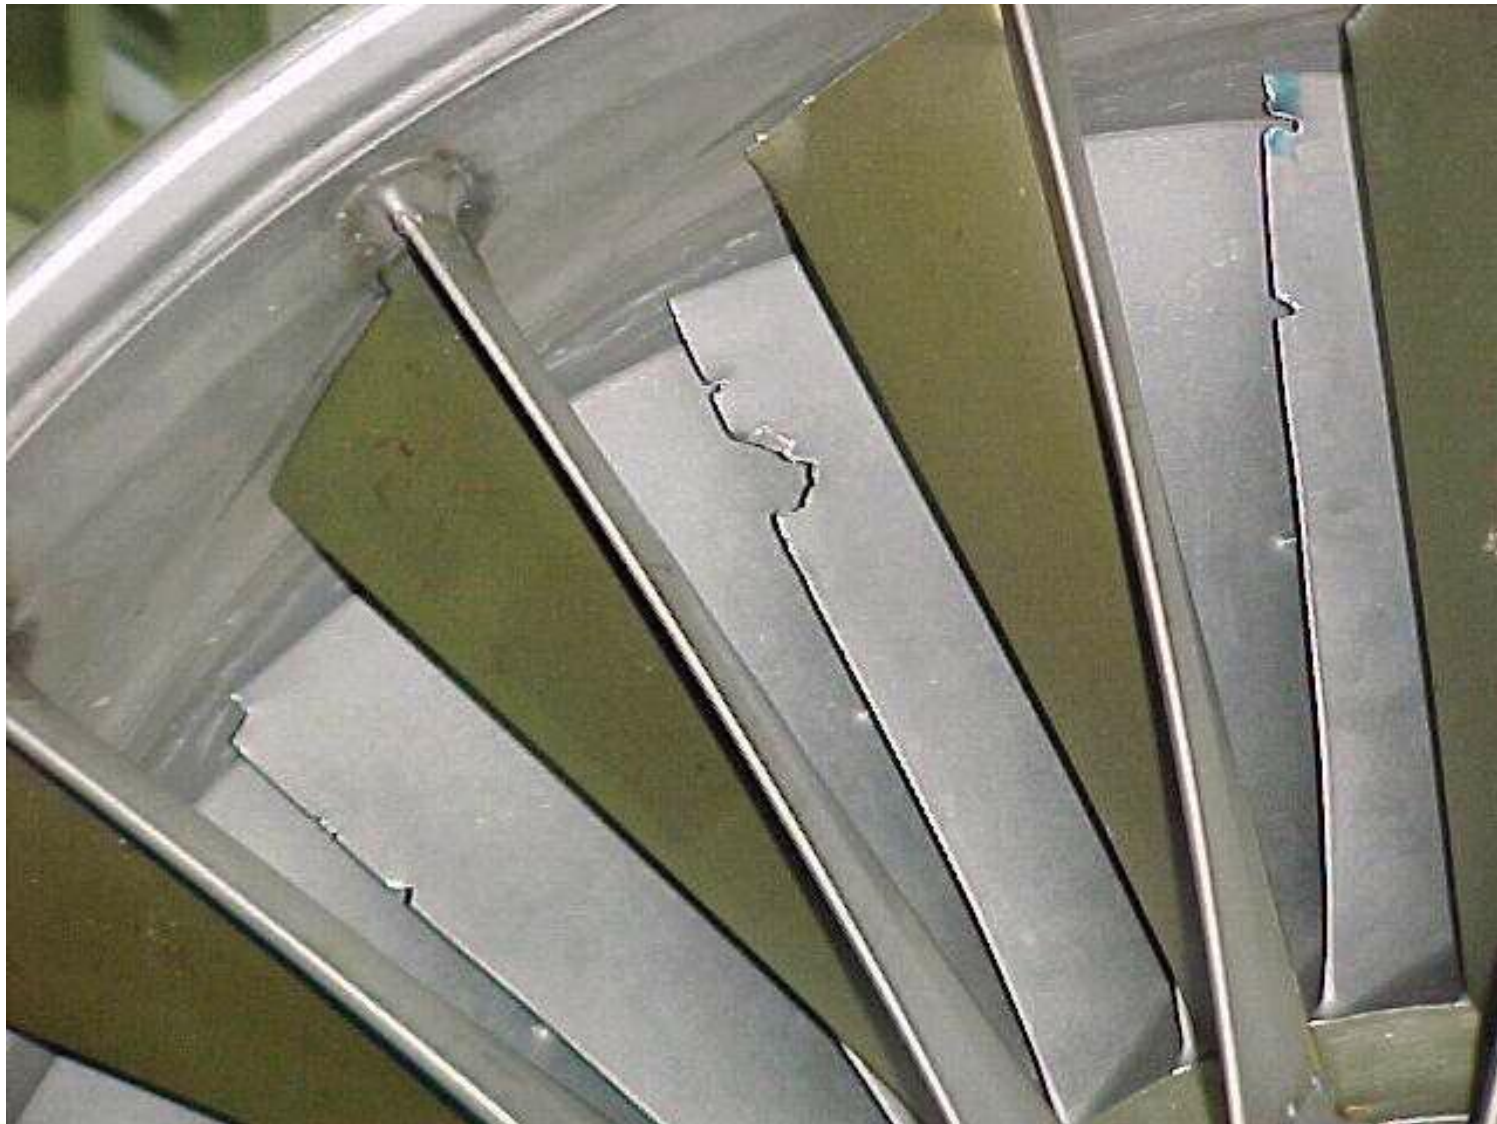
# Damage Caused By Concrete

(Photo Courtesy of Failure Analysis Service Technology)

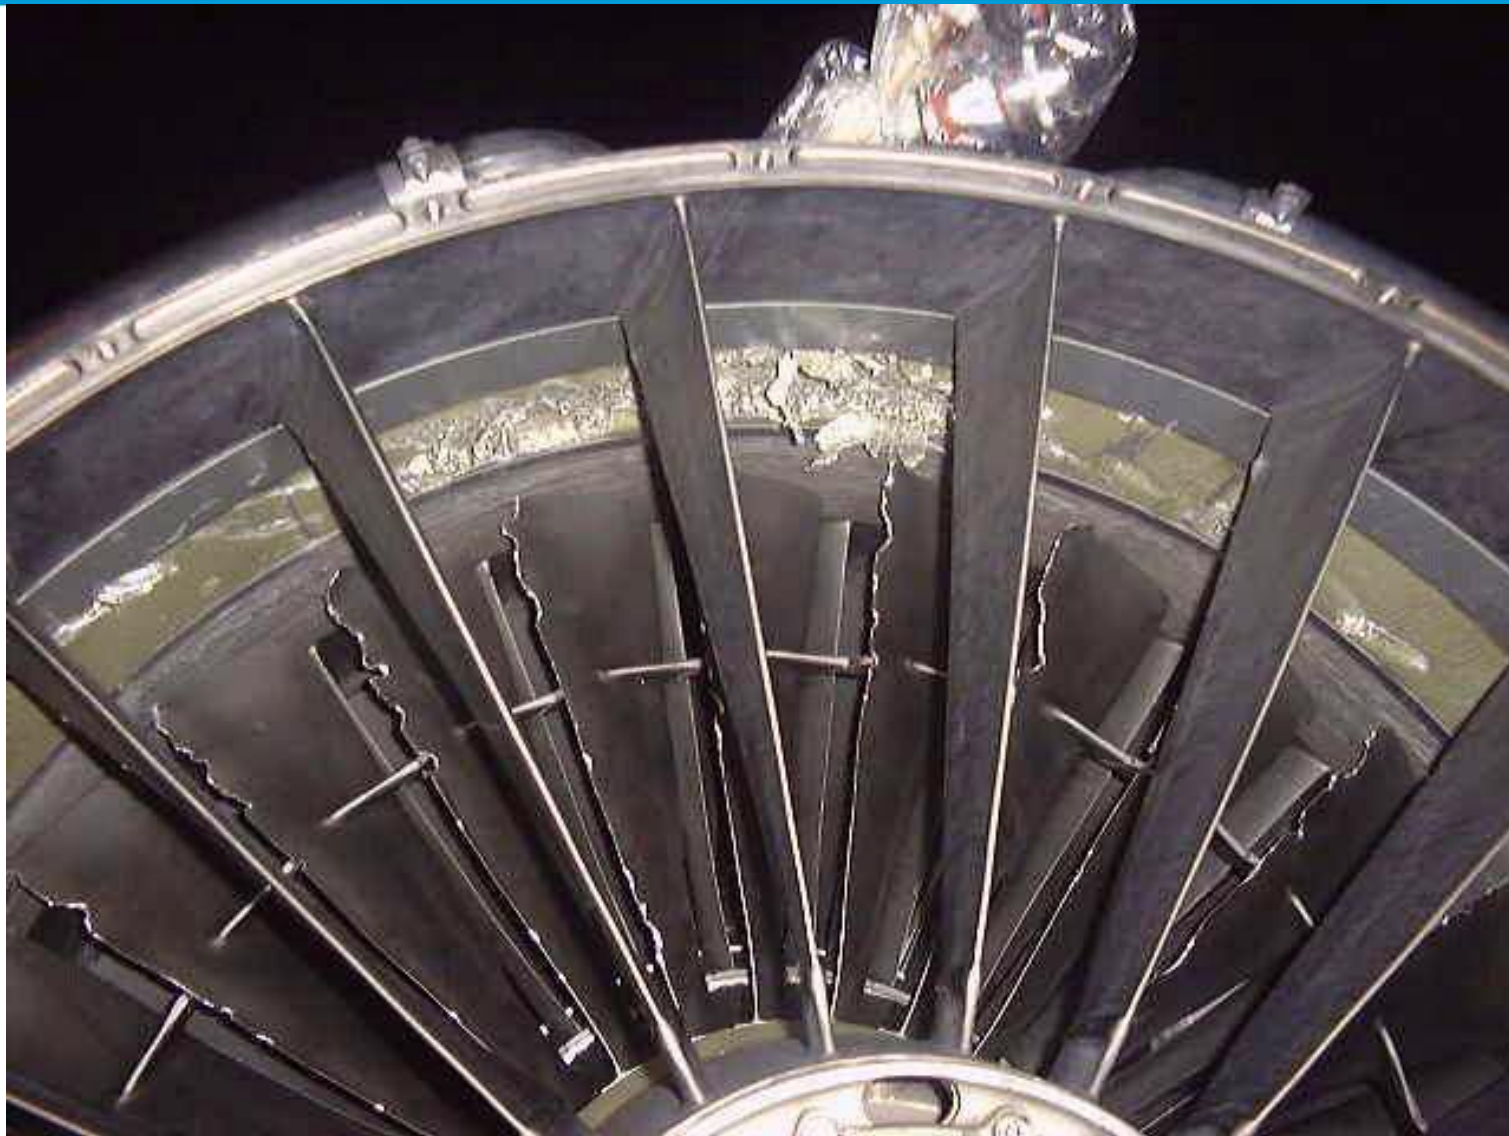
# Damage Caused By a Tool

(Photo Courtesy of Failure Analysis Service Technology)

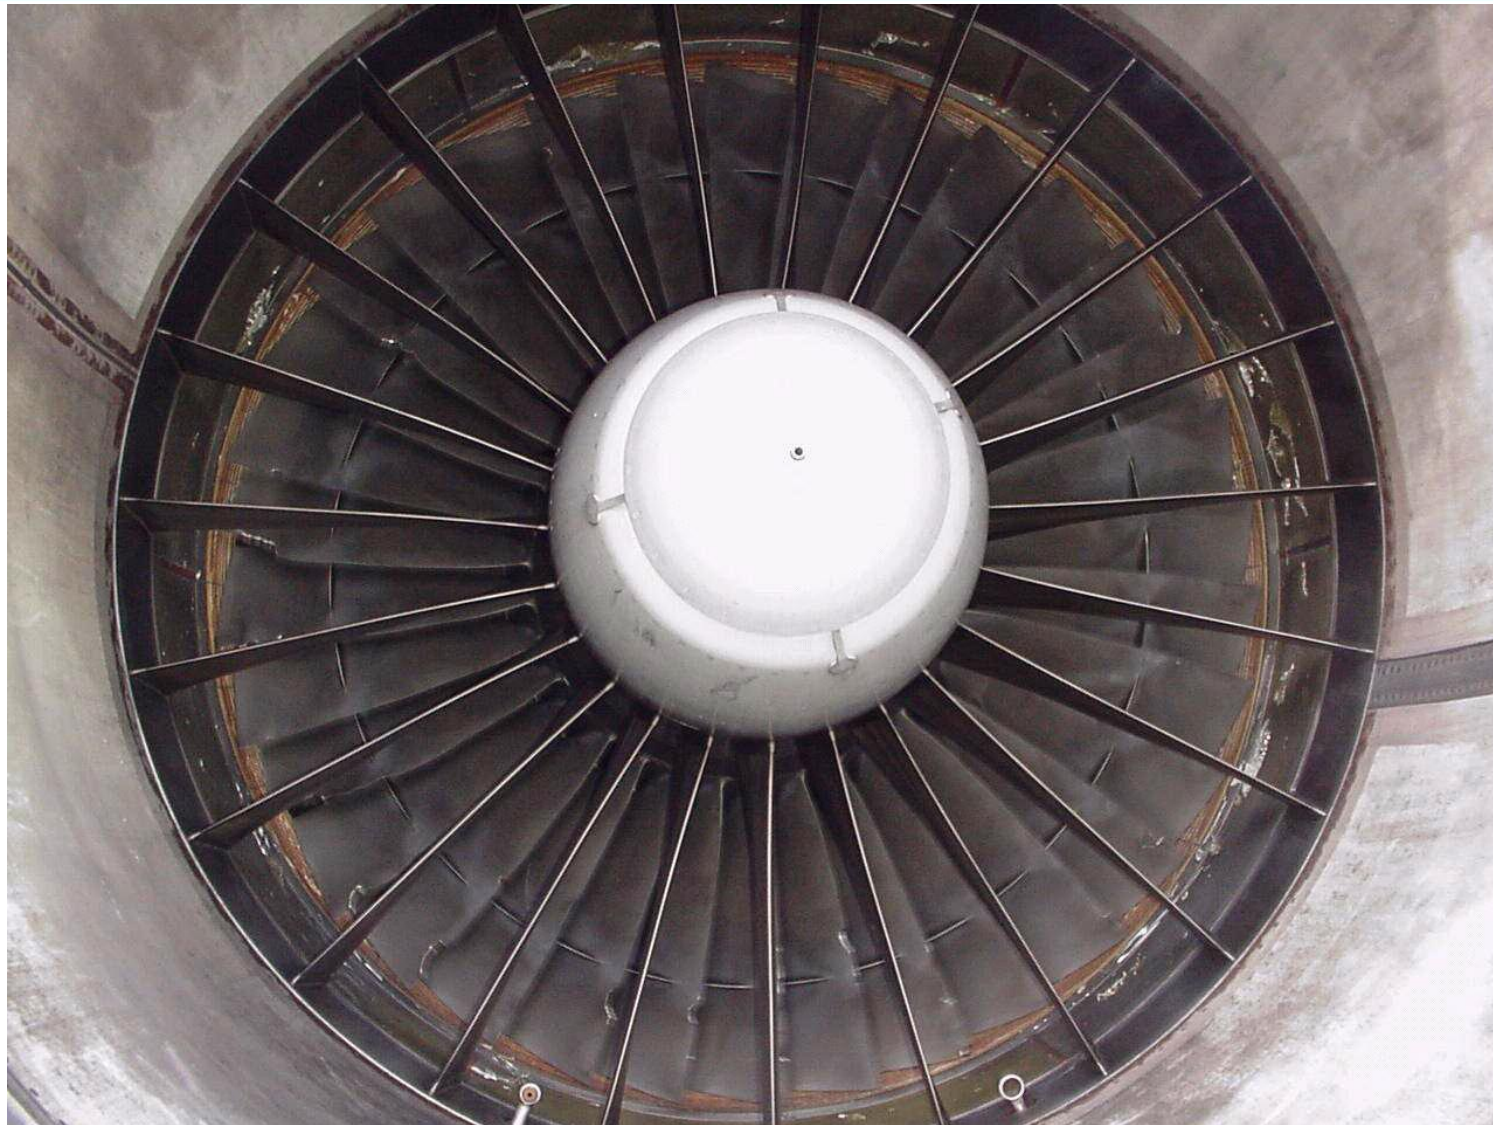
# Damage Caused by Hard Ice

(Photo Courtesy of Failure Analysis Service Technology)

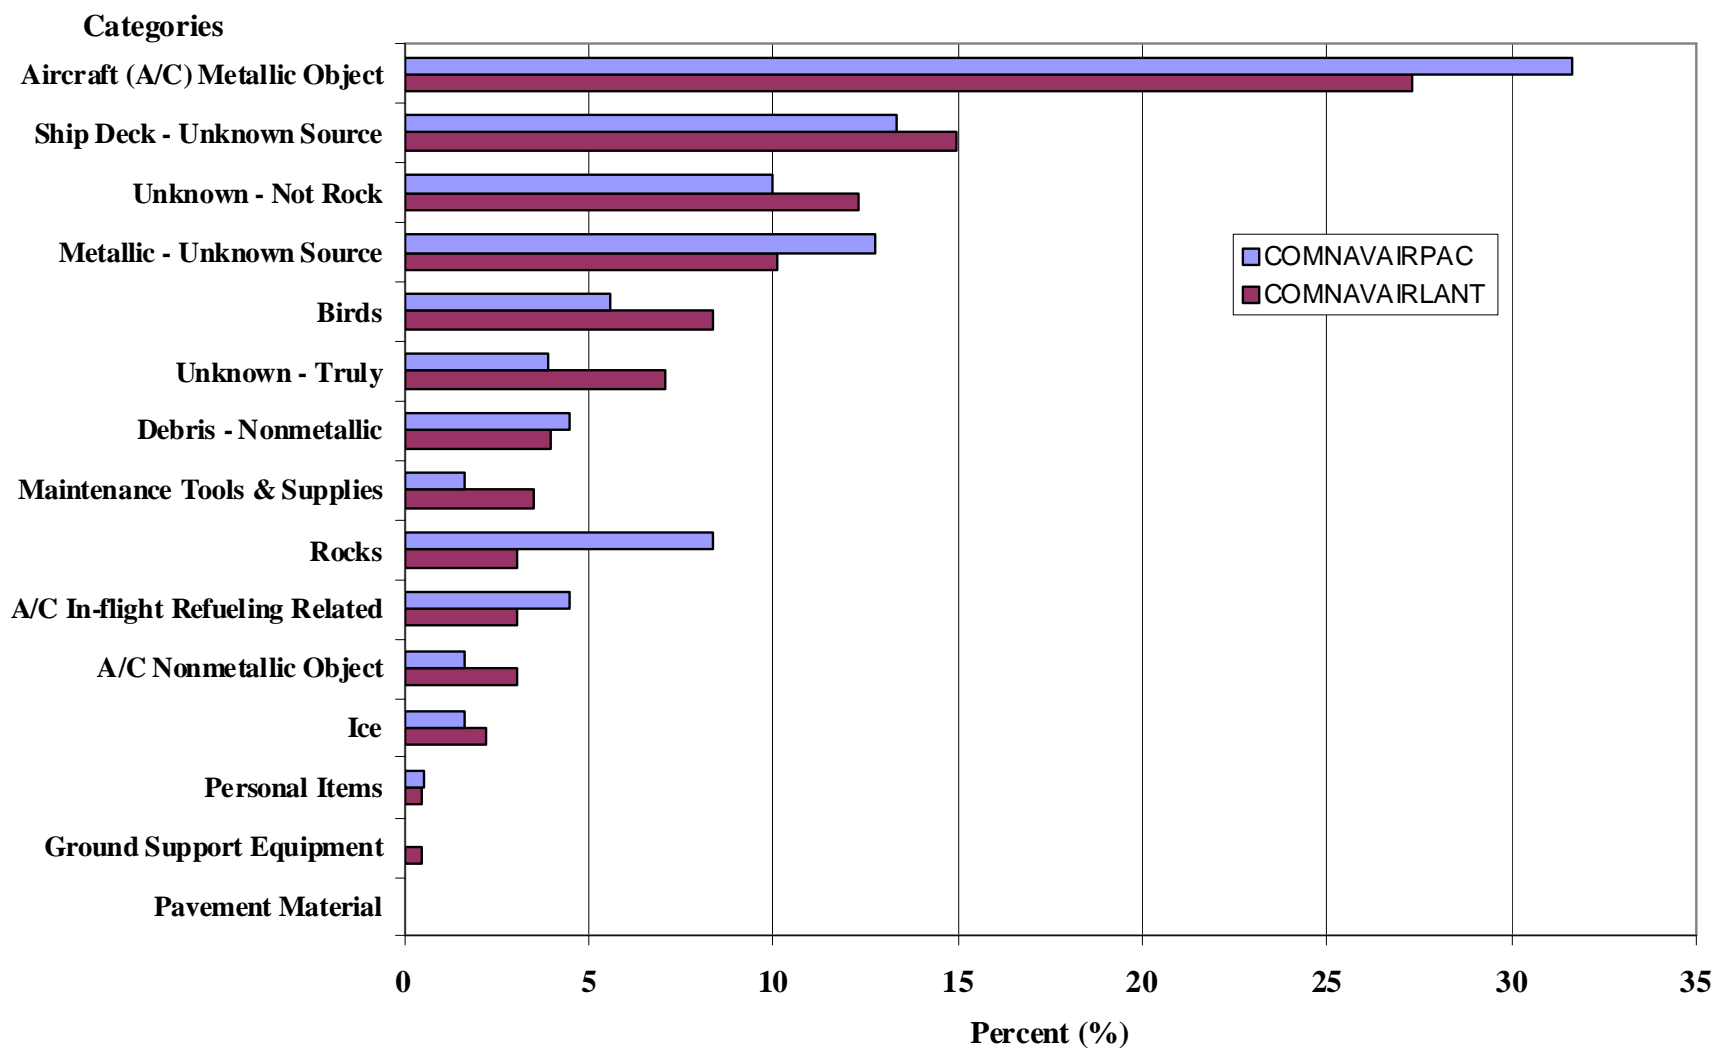
# COMNAVAIRLANT & COMNAVAIRPAC FOD Incidents

(January 2002 – March 2003)

Cause	Total Incidents	Percent
Aircraft Metallic Object	119	29.2
Ship Deck – Unknown Source	58	14.3
Metallic – Unknown Source	46	11.3
Unknown – Not Rock	46	11.3
Birds	29	7.1
Unknown – Truly	23	5.7
Rocks	22	5.4
Debris – Nonmetallic	17	4.2
Aircraft In-flight Refueling Related	15	3.7
Maintenance Tools and Supplies	11	2.7
Aircraft Nonmetallic Object	10	2.5
Ice	8	2.0
Personal Items	2	0.5
Ground Support Equipment	1	0.2
Pavement Material	0	0.0
<b>Totals:</b>	<b>407</b>	<b>100.0</b>

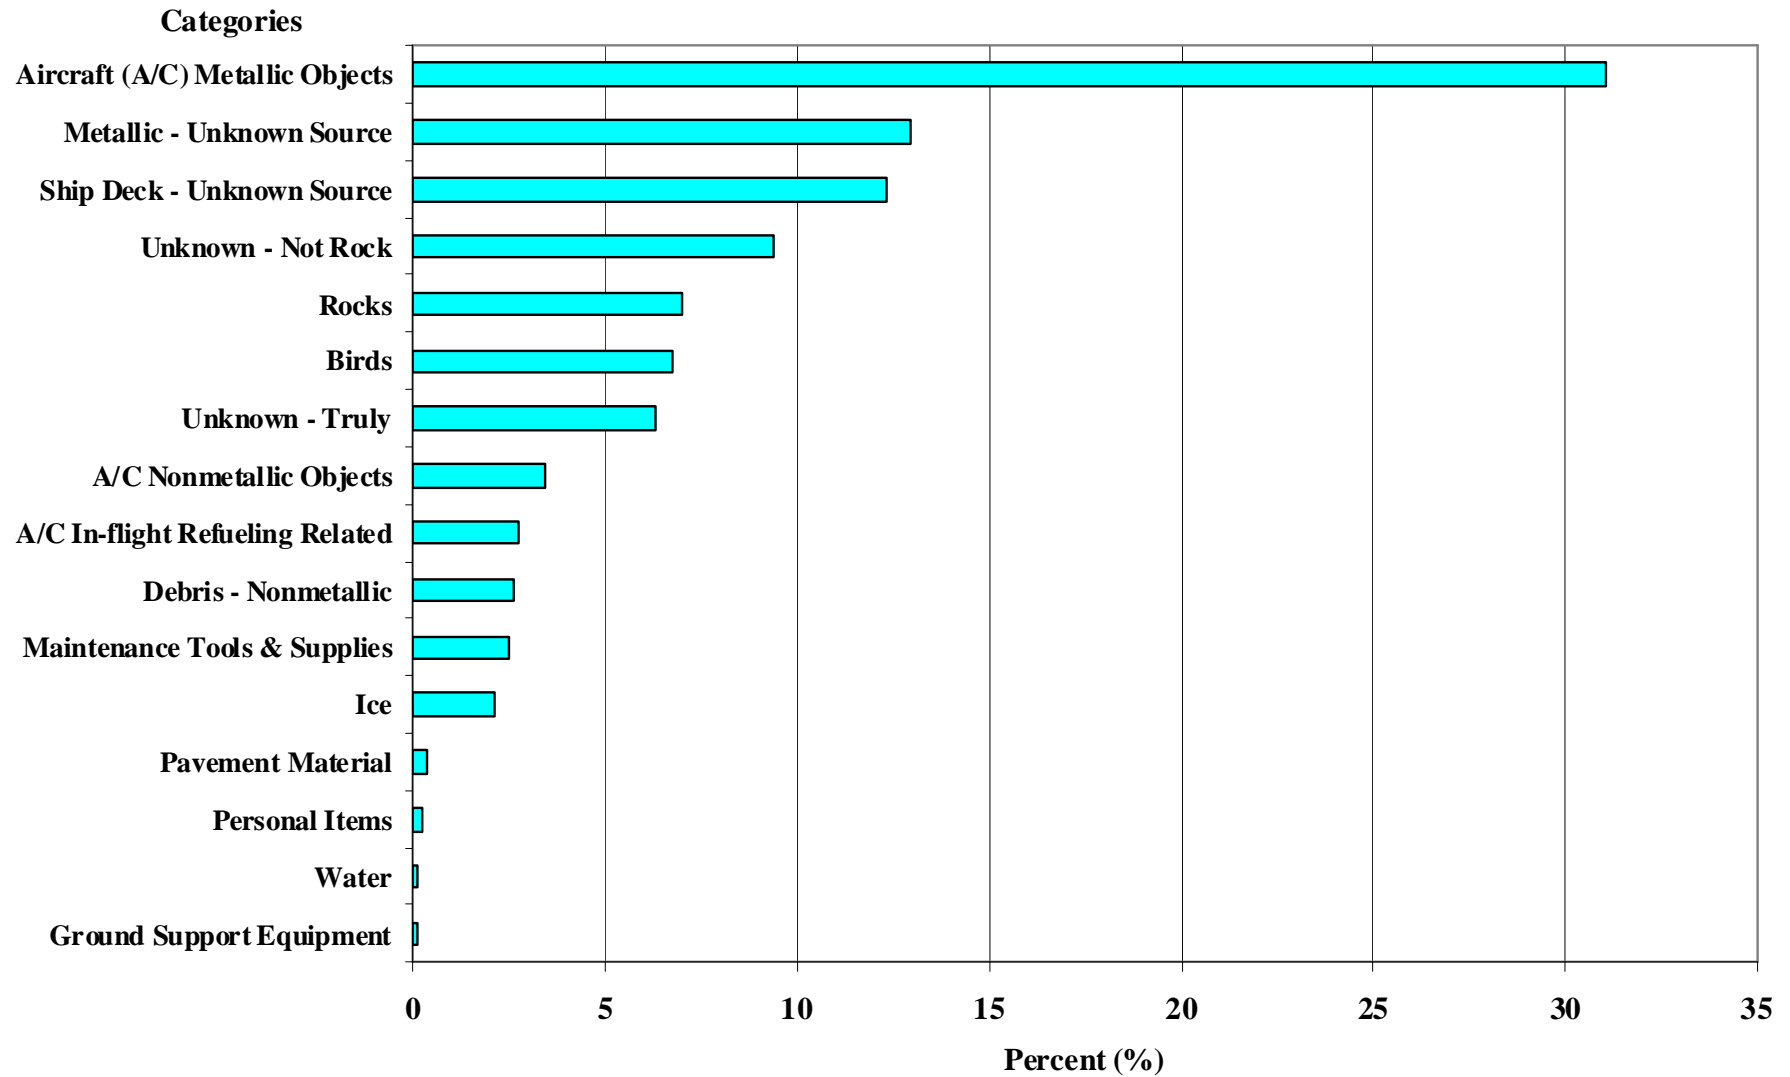
## FOD Incidents – All Collected Data

Cause	Total Incidents	Percent
Aircraft Metallic Object	262	31.1
Metallic – Unknown Source	109	12.9
Ship Deck – Unknown Source	104	12.3
Unknown – Not Rock	79	9.4
Rocks	59	7.0
Birds	57	6.8
Unknown – Truly	53	6.3
Aircraft Nonmetallic Object	29	3.4
Aircraft In-flight Refueling Related	23	2.7
Debris – Nonmetallic	22	2.6
Maintenance Tools and Supplies	21	2.5
Ice	18	2.1
Pavement Material	3	0.4
Personal Items	2	0.2
Ground Support Equipment	1	0.1
Water	1	0.1
Totals:	843	100
